2014 Middle & Lower Bolton Lakes Drawdown

Middle Bolton Lake Water Chemistry at MBOUT 2014 Before Drawdown ● After Drawdown ▼ Horizontal Lines Define Intake Depth – After Drawdown Depths Adjusted to Intake

Lower Bolton Lake	Water Chemistry at LBIN	2014
-------------------	-------------------------	------

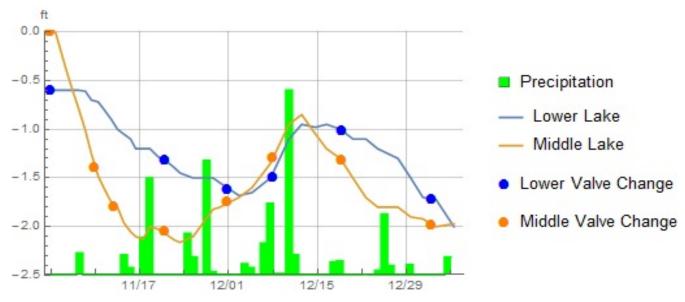
Valve Settings - in² open

Date	Lower	Middle
Nov 03	280	279
Nov 10		138
Nov 13		77
Nov 21	154	28
Dec 01	98	37
Dec 08	154	125
Dec 19	280	264
Jan 2	349	309

Significant Precipitation - in

Date	> 0.10
Nov 07	0.23
Nov 14	0.21
Nov 17	0.39
Nov 18	1.00
Nov 24	0.43
Nov 25	0.19
Nov 27	1.18
Dec 03	0.12
Dec 06	0.33
Dec 07	0.74
Dec 10	1.90
Dec 11	0.21
Dec 17	0.14
Dec 18	0.15
Dec 25	0.63
Dec 29	0.11
Jan 04	0.19

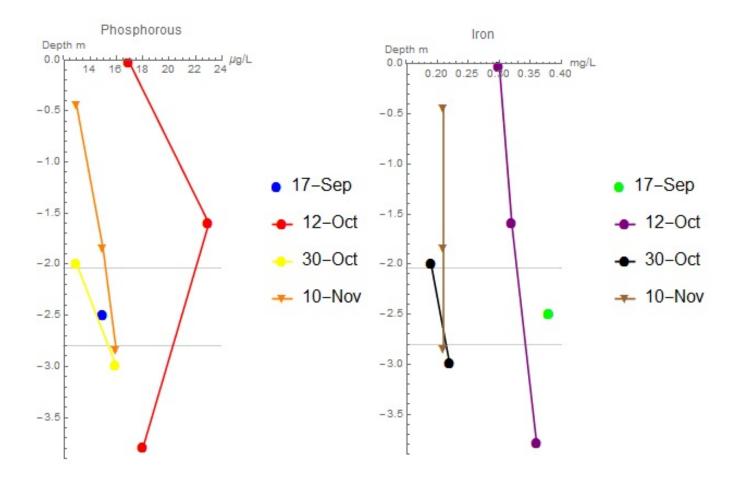
Date	Depth	P μg/L	Fe mg/L	Fe::P
17-Sep	-2.50	15.0	0.38	25.
12-Oct	-0.03	17.0	0.30	18.
12-Oct	-1.60	23.0	0.32	14.
12-Oct	-3.80	18.0	0.36	20.
30-Oct	-2.00	13.0	0.19	15.
30-Oct	-3.00	16.0	0.22	14.
10-Nov	-0.45	13.0	0.21	16.
10-Nov	-1.85	15.0	0.21	14.
10-Nov	-2.85	16.0	0.21	13.

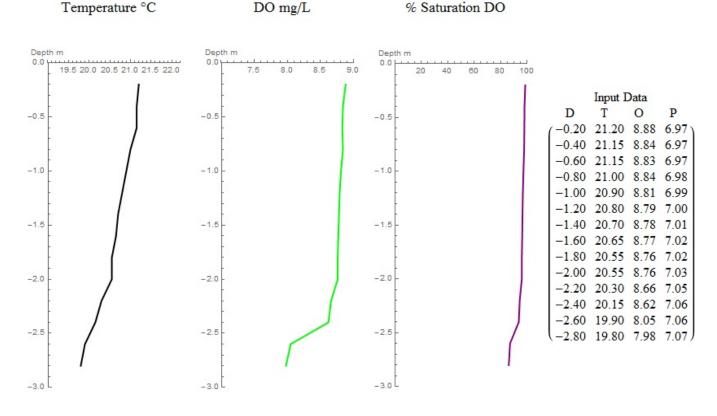
Middle Bolton Lake September 17, 2014, 02:15 PM Station: MBOUT Secchi 2.2 m Weather: Sunny, North West Wind Notes: Clump of Najas Guadelupensis on Anchor. Water Sample at 2.5 m.

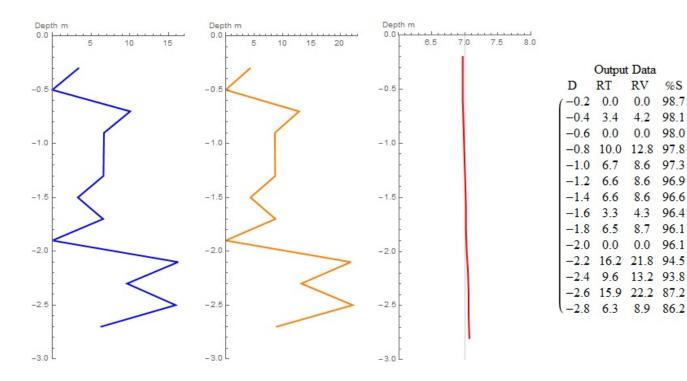
Middle Bolton LakeOctober 12, 2014, 04:01 PMStation: MBOUTSecchi 1.8 mWeather: Clear, Sunny, Light Variable BreezeNotes: Water Samples at 0, 1.6 & 3.4. Water Level at 0 KP Scale.

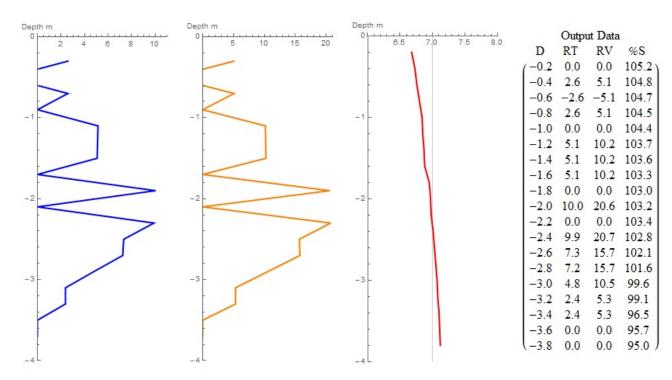
Middle Bolton LakeOctober 30, 2014, 01:24 PMStation: MBOUTCollectors: PVSecchi 1.6 mWeather: Partially Cloudy, Variable W BreezeNotes: No Secchi Scope. New DEEP Gauge at 0.0 ft. No Flow Over Dam. H2O @ 2m & 3m.

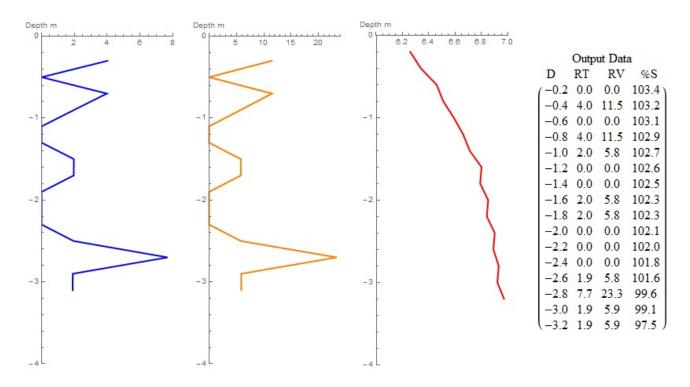
Middle Bolton LakeNovember 10, 2014, 12:56 PMStation: MBOUTSecchi 1.6 mWeather: Sunny, Light S Breeze.Notes: Both Dams in Drawdown. DEEP Gauge @ -1.5 ft. H2O @ 0, 1.4 & 2.4 m.

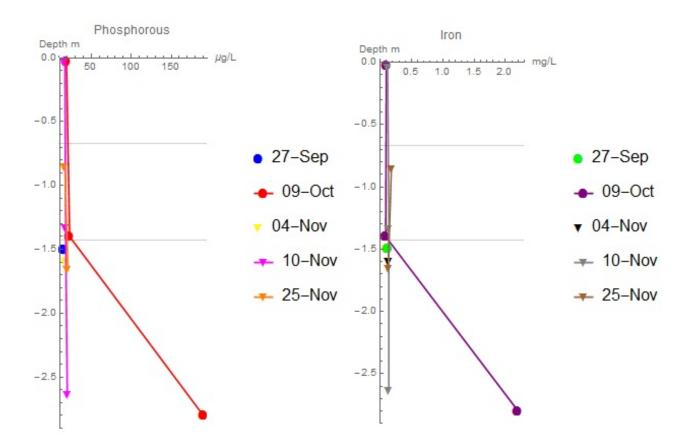
Figure 6

- Before Drawdown
- After Drawdown V

Horizontal Lines Define Discharge Depth - After Drawdown Depths Adjusted to Discharge

Date	Depth	P μg/L	Fe mg/L	Fe::P
27-Sep	-1.50	16.0	0.12	8.
09-Oct	-0.03	19.0	0.10	5.
09-Oct	-1.40	23.0	0.09	4.
09-Oct	-2.80	190.	2.20	12.
04-Nov	-1.60	18.0	0.14	8.
10-Nov	-0.04	17.0	0.12	7.
10-Nov	-1.34	18.0	0.14	8.
10-Nov	-2.64	20.0	0.14	7.
25-Nov	-0.86	17.0	0.18	11.
25-Nov	-1.66	21.0	0.13	8.

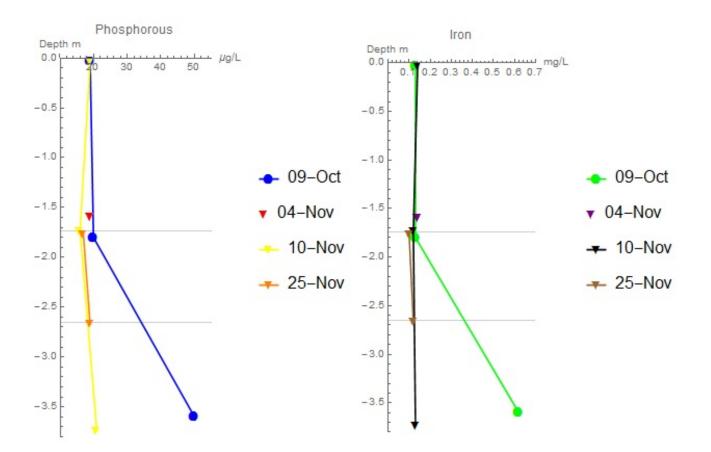
Before Drawdown •

After Drawdown V

Horizontal Lines Define Intake Depth - After Drawdown Depths Adjusted to Intake

Date	Depth	Ρµg/L	Fe mg/L	Fe::P
09-Oct	-0.03	19.0	0.13	7.
09-Oct	-1.80	20.0	0.13	7.
09-Oct	-3.60	50.0	0.62	33.
04-Nov	-1.60	19.0	0.14	7.
10-Nov	-0.04	19.0	0.14	7.
10-Nov	-1.74	16.0	0.12	8.
10-Nov	-3.74	21.0	0.13	6.
25-Nov	-1.77	17.0	0.10	6.
25-Nov	-2.67	19.0	0.12	6.

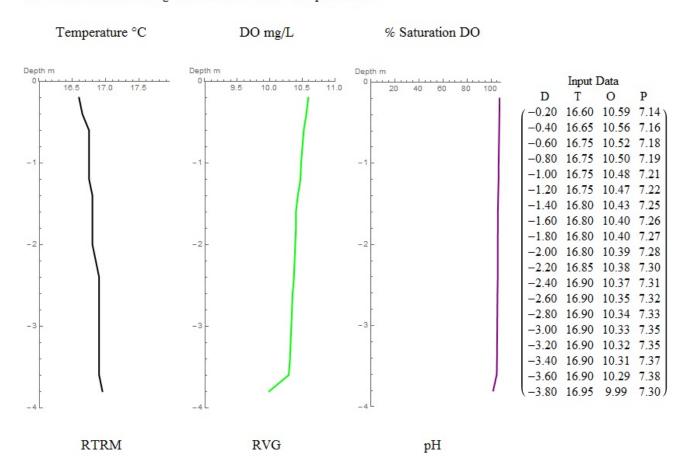
Lower Bolton Lake October 25, 2014, 04:32 PM Secchi 1.6 m Weather: Sunny, Light SW Breeze Notes: No Secchi Scope. DEEP Gauge -0.5 ft.

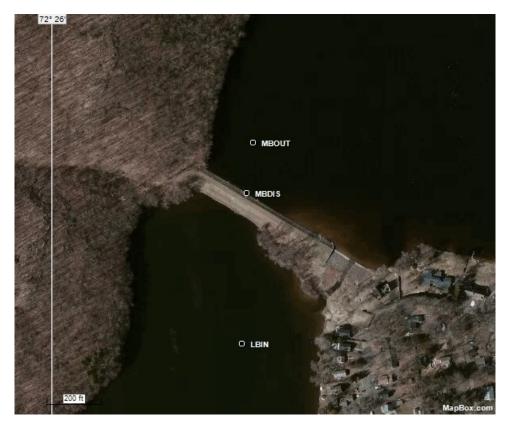
Location of MBOUT & LBIN Stations MBDIS is Location of Middle Lake Discharge

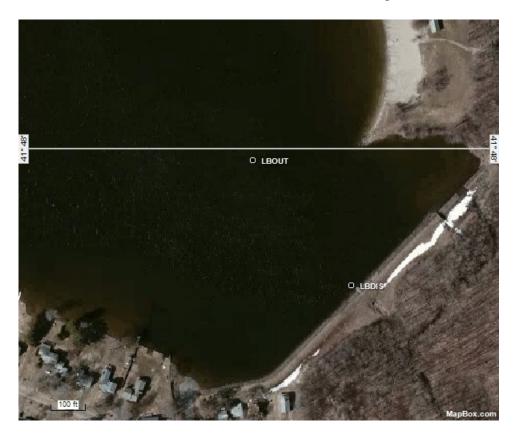
Location of LBOUT Station LBDIS is Location of Lower Lake Discharge
