Middle Bolton Lake Fanwort Status and Recommendations

*by
The Friends of Bolton Lakes
August 10, 2017*

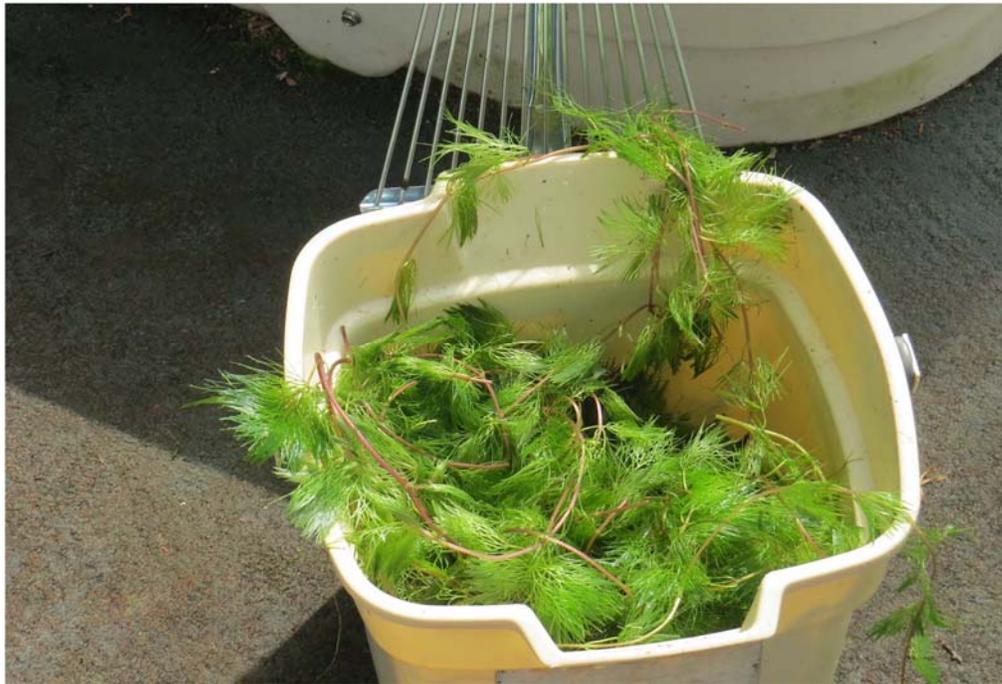
Figure 1 An outing's collection of fanwort fragments by several volunteers. Fragments typically range in length from a few inches to several feet. They are found either floating in the lake or washed up on the shoreline.

Residents have recovered numerous additional fragments, but without GPS data, we only report these in approximate regions. Fragments are found both floating and “landed” along the shoreline rocks/plants on a daily basis. They range in length from only a few inches to several feet. Figure 1 is a single outing’s collection while Figure 2 provides a better view of what a plant fragment looks like when floating in water.

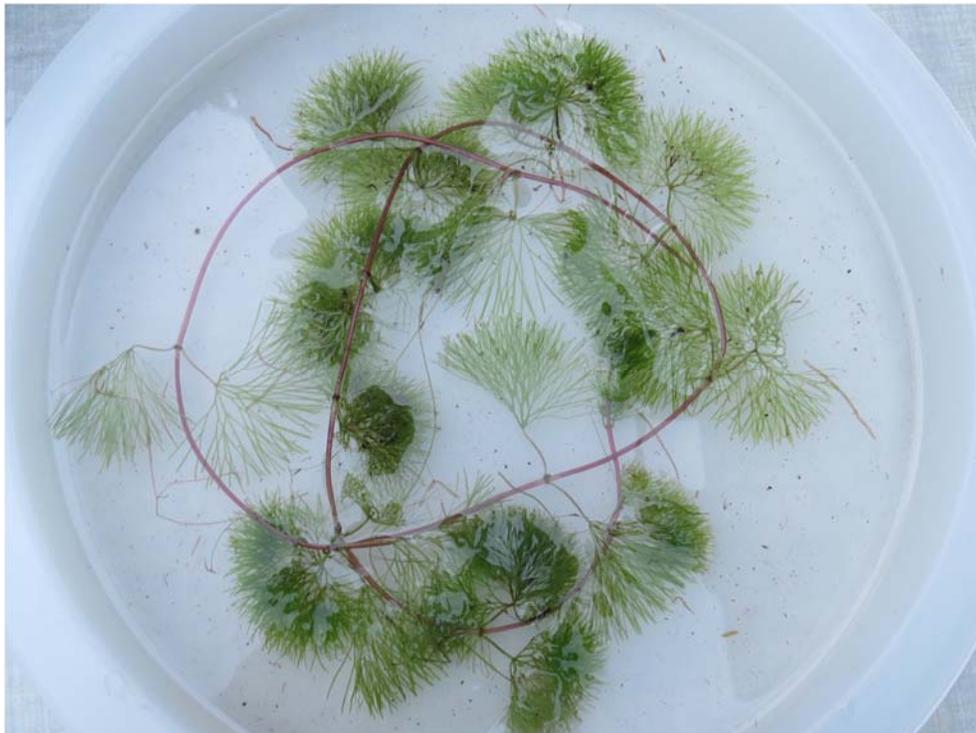
Figure 2 Example of a single fanwort fragment taken from Middle Lake. It is easiest to identify if you float it in a shallow pan of water to see the foliage
